## APPRAISAL REPORT

130 Queen Avenue  
Pointe-Claire (Québec)

Subject Valuation report for demolition purposes, relating to the new and depreciated replacement cost, as well as the estimate of the potential renovation costs  
Location 130 Queen Avenue, Pointe-Claire (Québec)  
O/File 656583E

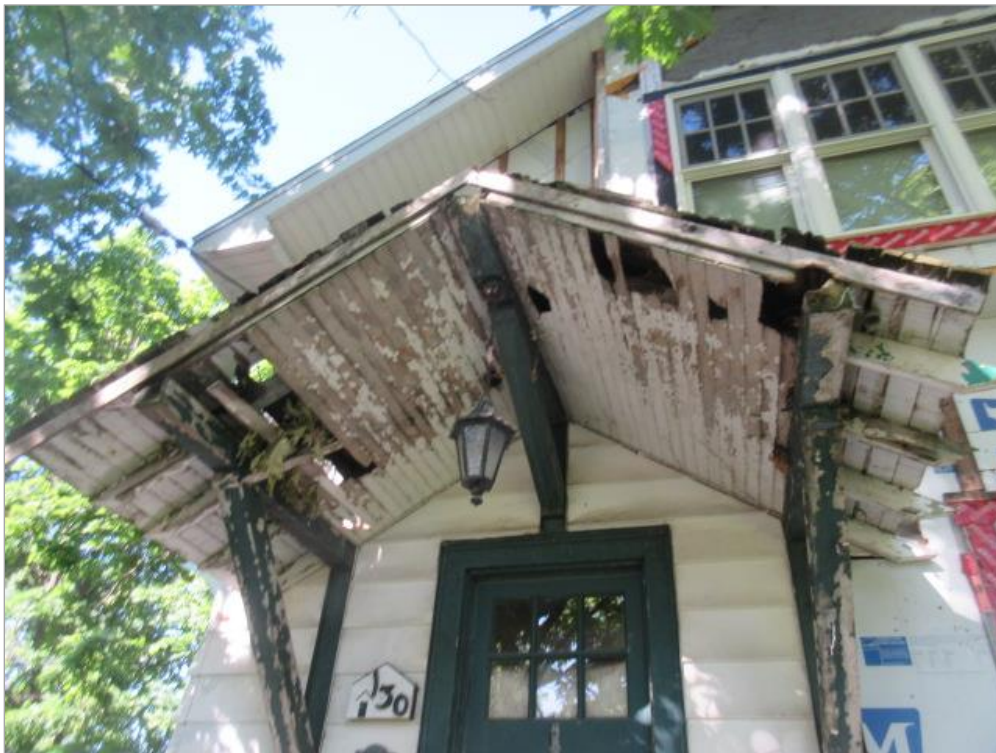
**Canopy**

FLASHINGS AND SEALS	<p>The sealing joints are damaged in several places. Redo the joints where required.</p>
DOORS AND WINDOWS	<p>Doors should be replaced. Windows have reached the end of their useful life. Provide for a complete repair of windows and patio doors.</p>
TERRACES, BALCONIES AND PORCHES	<p>The rear terrace is in a very poor state. Provide for a short-term repair of the whole.</p>
SOFFITS	<p>Clear soffits and check ventilation. There are soffit fascia sections missing.</p>
OUTDOOR LAYOUT	<p>The left side yard needs to be cleaned to keep its wholesomeness. Clean the yard.</p>
ROOF CLADDING	<p>The roof and canopies need to be replaced shortly.</p>

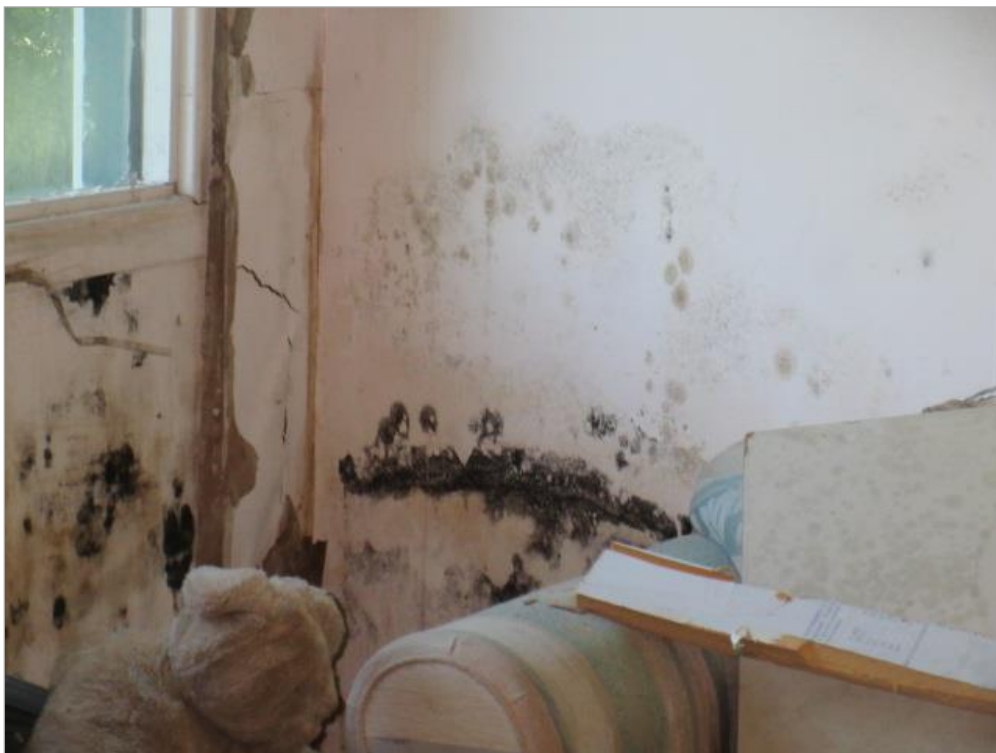
**Mold on plaster**

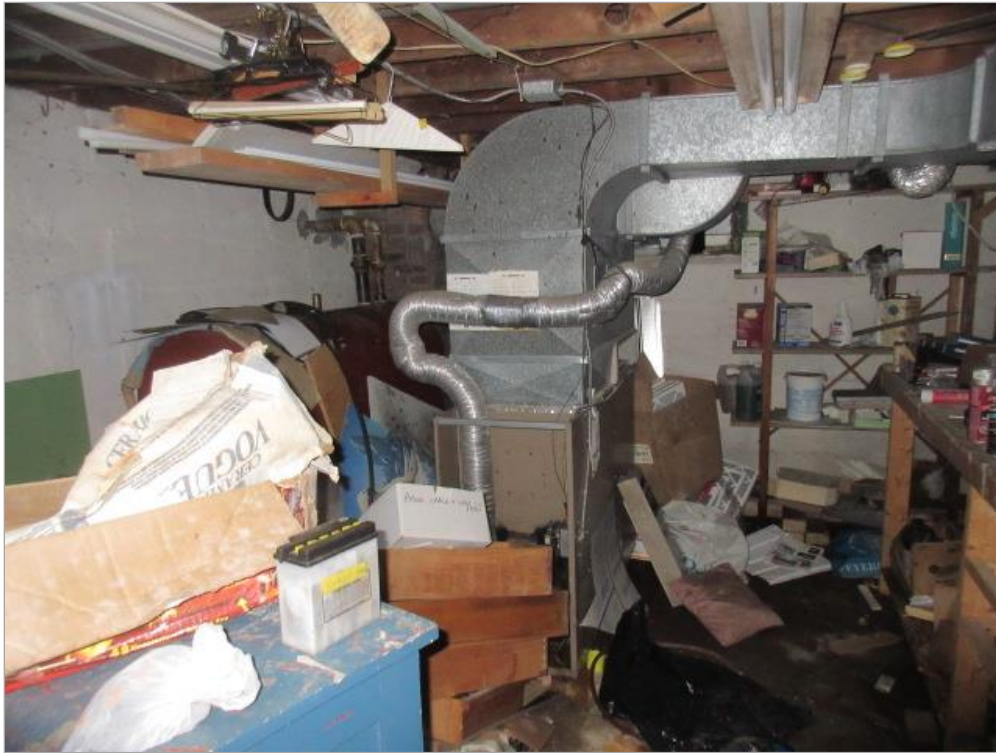
**Mechanical room**

HEATING AND AIR-CONDITIONING	Provide for the replacement of the electric furnace.
FIREPLACE	The fireplace and chimney flue are to be replaced.
FLOOR FINISHES	The wooden floors are damaged or contaminated. The ceramic tiles are cracked. Repair floor coverings.
WALLS AND CEILINGS	<p>We noticed wall sections to be repaired, holes in gypsum walls as well as repairs in progress. Carry out the necessary work.</p> <p>Presence of mold was noted in several places on the plaster walls. Decontaminate the whole.</p>
Kitchen	The kitchen cabinets are probably original. Due to the deteriorated state of the kitchen, plan a complete renovation.
INSULATION AND VENTILATION	We noticed that the soffits are poorly ventilated. Carry out the necessary work.

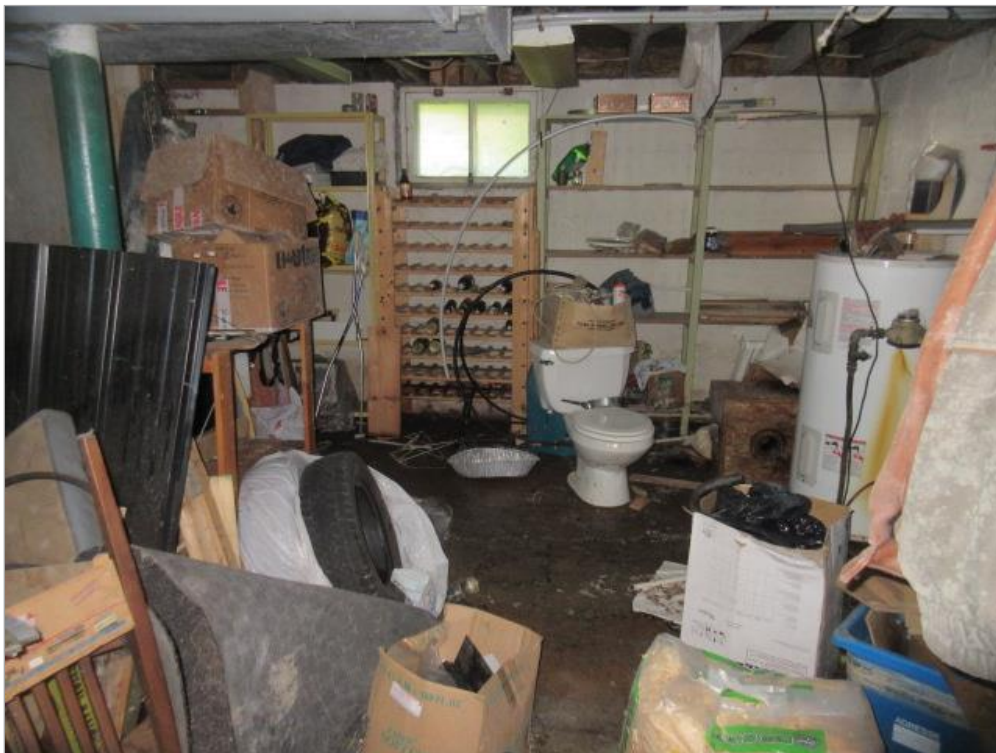
**Basement**

FOUNDATIONS	<p>Several cracks are observed on the concrete blocks foundation walls. Repair or replace the foundations.</p> <p>Water infiltration and stains are observed on the foundation walls. There may not be a French drain or it might be worn. Have the foundations inspected and install a French drain, if necessary.</p>
FLOOR SLAB	<p>The slab could not be inspected. However, traces of moisture were noticed in several places.</p>
FLOOR JOISTS	<p>There are possible traces of mold on joists and floor decking in the basement. Perform a mold test.</p> <p>The basement's subfloor shows signs of sagging.</p>
STRUCTURE	<p>The structure of the rear extensions undergoes subsidence. Have the structure of the building checked by a structural engineer if it can be preserved.</p> <p>Roofs are sagging.</p>
EXTERIOR CLADDING	<p>Aluminum siding covers the exterior walls. In some places, the exterior cladding is missing. We estimate that this siding should be replaced within a few years.</p>

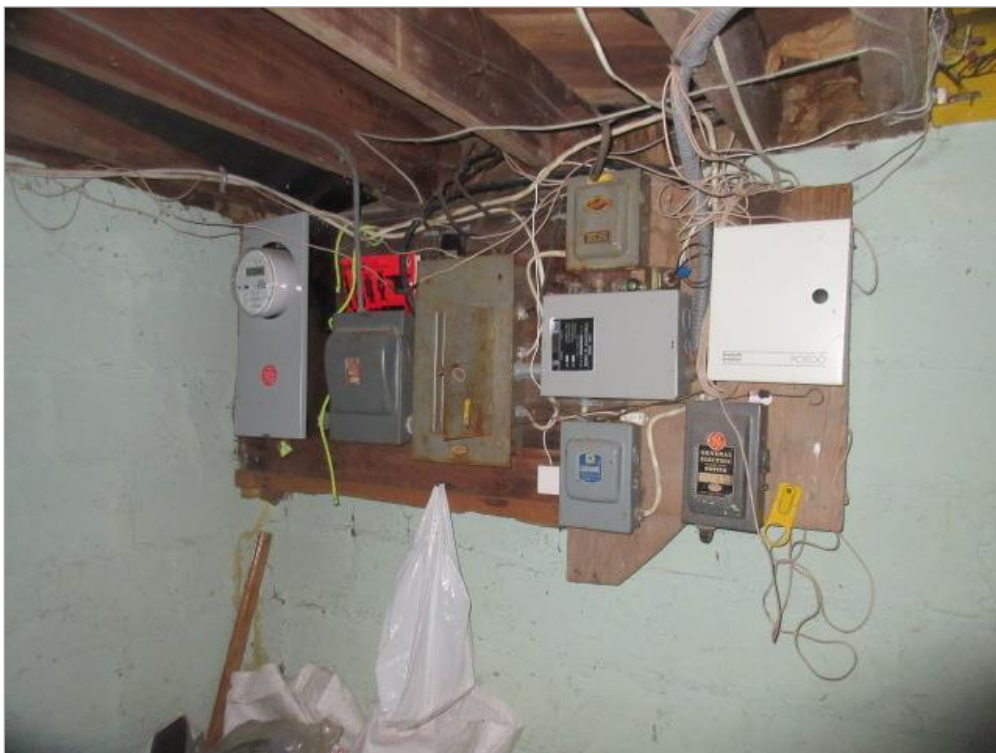
**Electrical panel**

GUTTERS	Gutters are missing from some roof overhangs. Have gutters installed at the bottom of each roof slope as well as outlets.
FLASHINGS	Proceed to install new flashings.
PLUMBING	<p>Several small plumbing repairs are to be expected to correctly optimize water management. Provide for the replacement of the shut-off valve and the installation of water hammer dampers under each plumbing fixture.</p> <p>Have the plumbing lines checked by a competent plumber, since several deficiencies are observed.</p>
ELECTRICITY	<p>The power supply cables pass through tree foliage. Have the trees pruned.</p> <p>We noticed electrical cables without a protective cover. Remove the cables or insert them into junction boxes. Plan an upgrade. Attach the free junction box to a structural element. Replace unprotected outlets with GFCI outlets. Have the outlets and grounding checked by an electrician. Replace the electrical distribution panel.</p>
