APPRAISAL REPORT

130 de la Pointe-Claire Avenue
Pointe-Claire (Quebec)

O/File 667867E

Subject Valuation report for demolition purposes, relating to the new and depreciated replacement costs, as well as the estimate of the potential renovation costs
Location 130 de la Pointe-Claire Avenue, Pointe-Claire (Quebec)
O/File 667867E

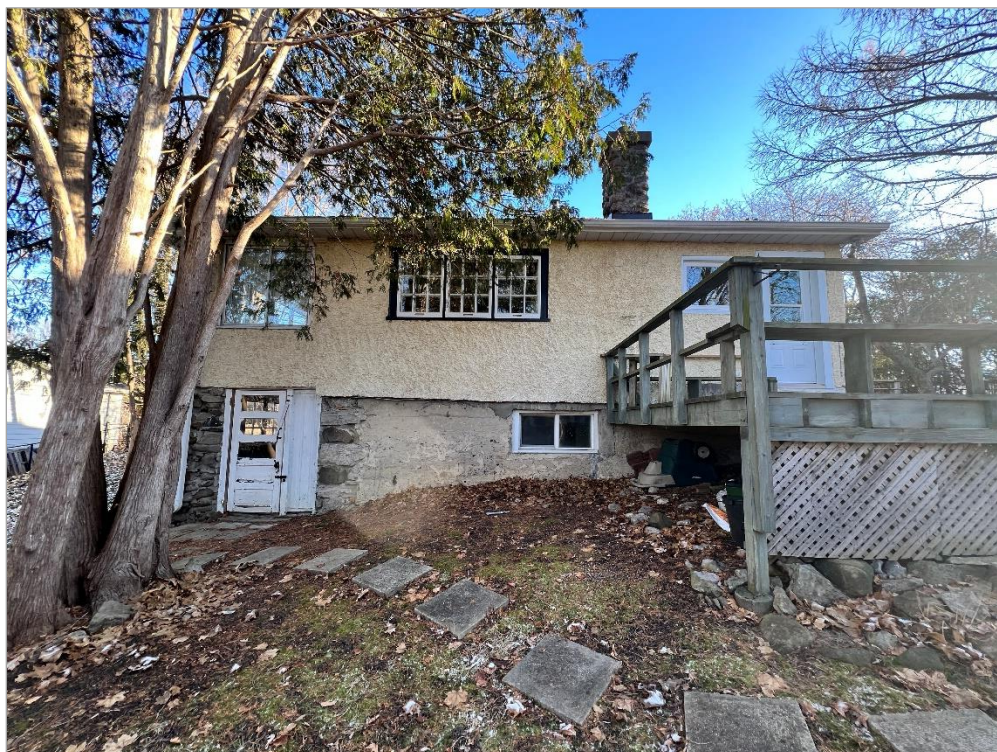
Rear side

We noticed cracks on the rear-side concrete foundation wall. Regularly check the condition of the foundation and note any widening cracks. If cracks become larger, a specialist assessment should be carried out.

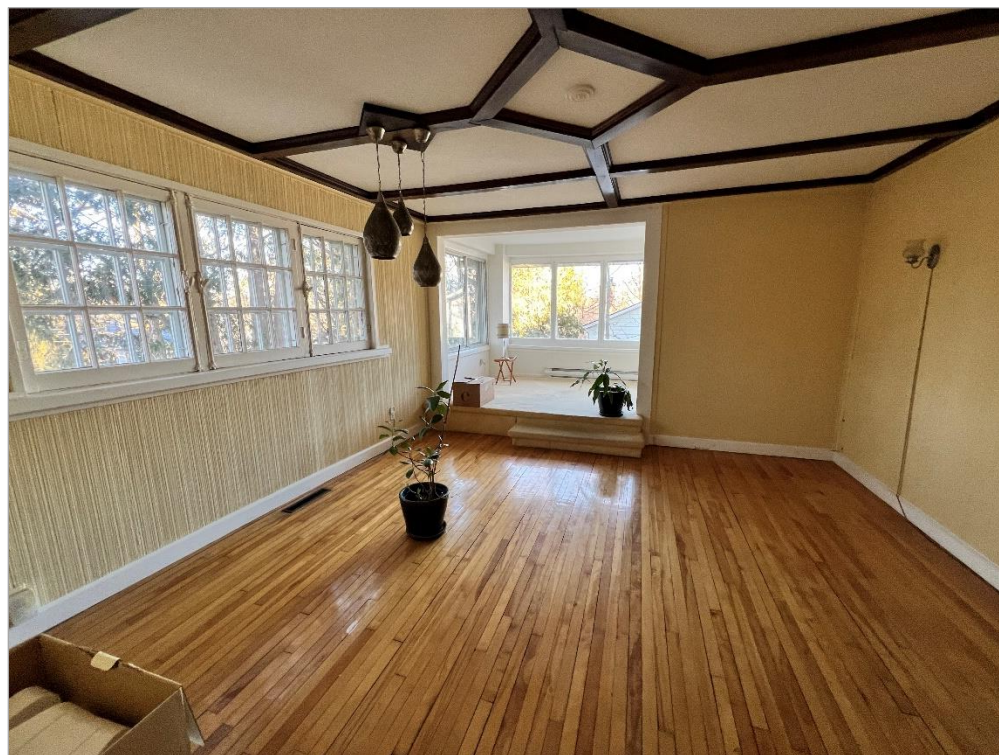
Dining room

We observed a vertical crack at the lower front corner of the dining room window. In our opinion, this is a crack caused by a lack of reinforcement of the pulled joints due to their position. Reinforce the crack by pulling the joints before repainting for a flawless finish.

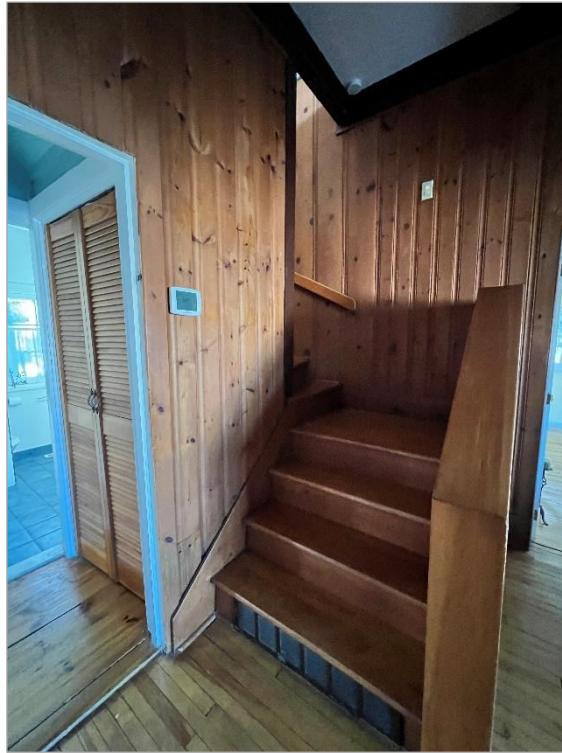
Stairs leading to the second floor

We noted irregularities in the staircase handrails. Install handrails on all flights of stairs.

We noted the absence of a safety railing at the top of the upstairs staircase. Restrict access to the risky area. We recommend installing guardrails on the upstairs landing, all around the opening.

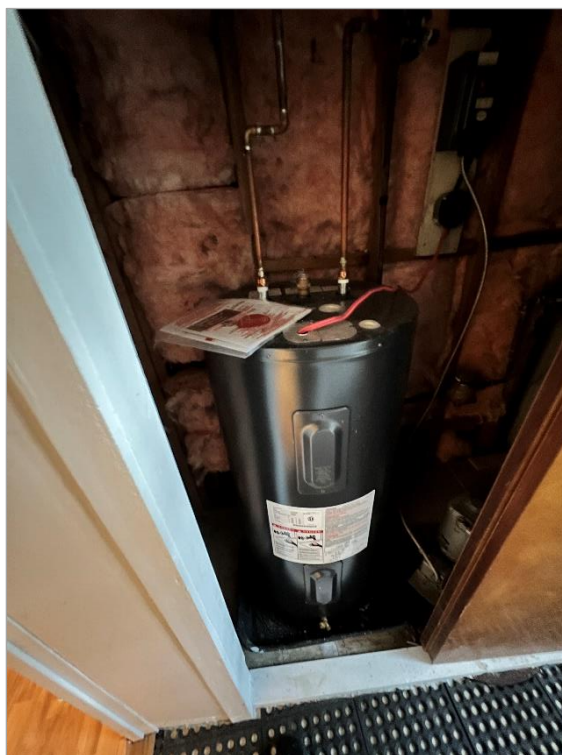
Hot water tank

The water heater has reached the end of its useful life. Plan to replace it in the short term. We have noted a deficiency in its installation. The Relief valve has no drain. Have a drain installed.

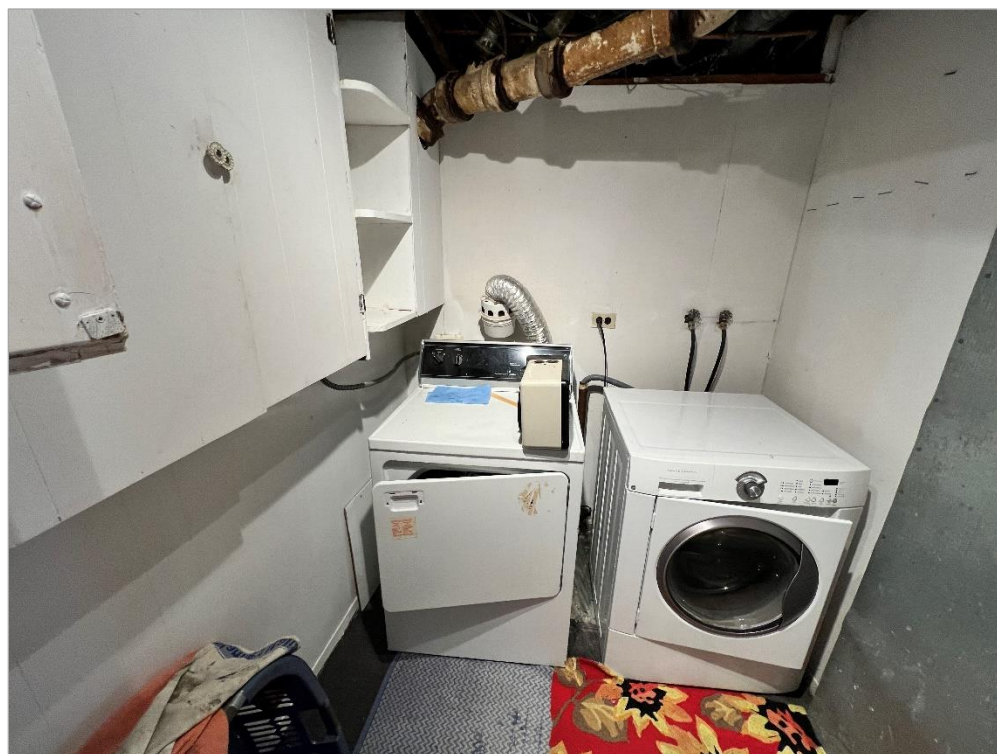
Laundry room

There's a badly stained laundry tub in the basement. Depending on its use, it may need to be replaced.
